State Historic Sites Inventory Form

historic Frame house

18912 Sandy Hook Road JH 12/1/05street & number north side of Sandy Hook Road, .35 mile east of Clark Road not for publicationcity, town Sandy Hook ☐ vicinity of ☐ congressional district sixthstate Maryland county Washington

Survey No. WA-III-088

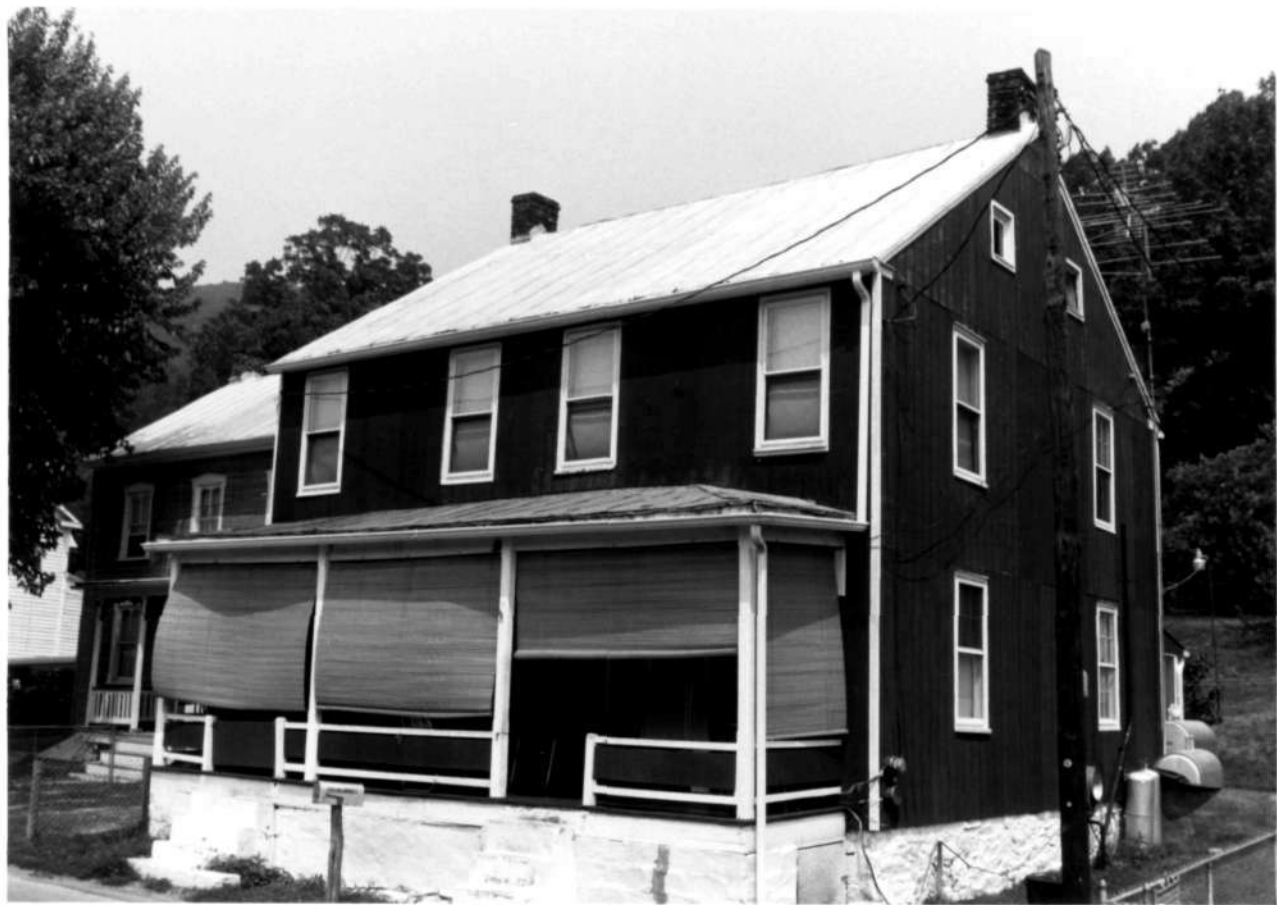
1. WA-III-088
2. Washington Co., Md.
3. Joe Getty
4. ~~April 1983~~ 7/82
5. Md. Hist. Trust, Annapolis, Md.
6. South elev. (camera facing north)
7. 1/1

The frame house is a two-story frame structure constructed in a rectangular plan. The main section is six-bays by two-bays with a full-length, one-story porch. The exterior has a vertical board siding. The structure has a gable roof covered in sheet metal. The structure appears to date from the late 19th century.

The two-story structure is constructed of frame covered in a vertical board siding. The structure is on a fieldstone foundation with a full-length, one-story front porch on a concrete block foundation. The front porch has a hipped roof covered in sheet metal and is supported on chamfered posts. The first story of the main section has six bays with entrances in the second and fifth bays. One-over-one sash windows are in the other bays of the first story. On the second story, windows are in the bays above the windows of the first story (with the bays above the doors being unfenestrated). The gable ends have windows on the first and second story and small windows in each gable. Some of the sash on the gable ends have six-over-six pane which is probably what was originally on the structure. The house has a gable roof covered in sheet metal. Interior-end brick chimneys rise from each gable end.
